CASE SUMMARY OF FWNE16OFF003472 FATAL BOATING ACCIDENT

SYNOPSIS

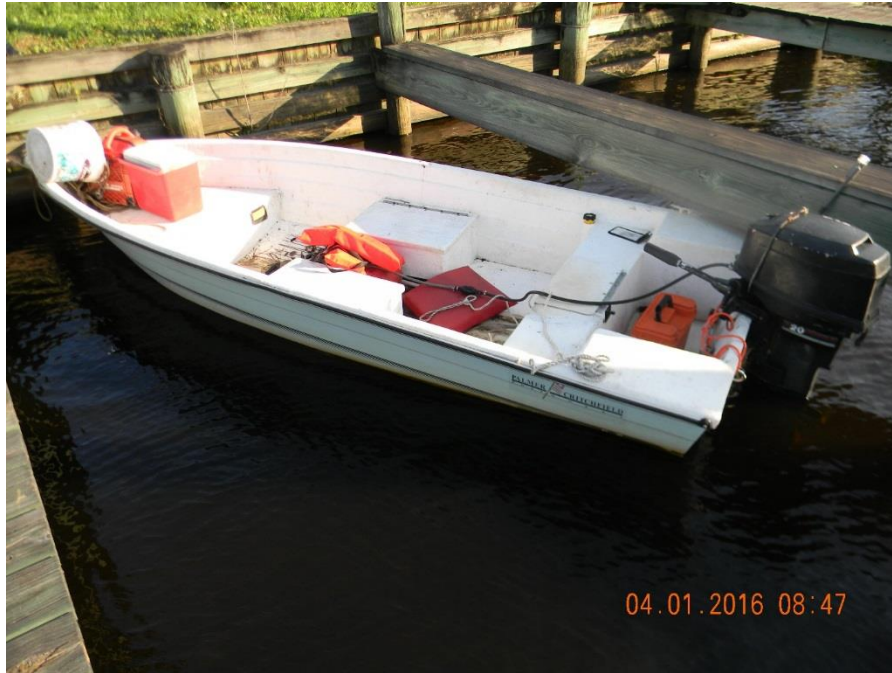
V-1 is a 2003 14'4" in length, 5'2" beam, Palmer Critchfield Boat a V-hull fiberglass skiff. V-1 is powered by a 20 hp Mercury tiller outboard motor with an aluminum 3 blade propeller. The inner hull is white and the outer hull is light blue with dark blue stripes on the side. It displays Florida registration number FL 6344 RX, Hull Identification Number (HIN) CXRC3044F303. The registered owner is Phillip William John of 108 Waterway Dr., Satsuma, FL 32177. V-1 has a rear fiberglass bench seat with a single compartment. There is one live well compartment on the port side mid ship and one fiberglass storage compartment on the starboard mid ship. V-1 has one forward fiberglass casting deck. The capacity plate is rated for 3 persons or 450 lbs., 750 lbs. persons, motor and gear, 25 horsepower maximum rating.

V-1 had a 6 gallon fuel tank with $\frac{1}{4}$ tank remaining. There is a 5 gallon portable spare fuel container. The navigational lights were clip on bow light and clip on stern light and they were functional at time of inspection.

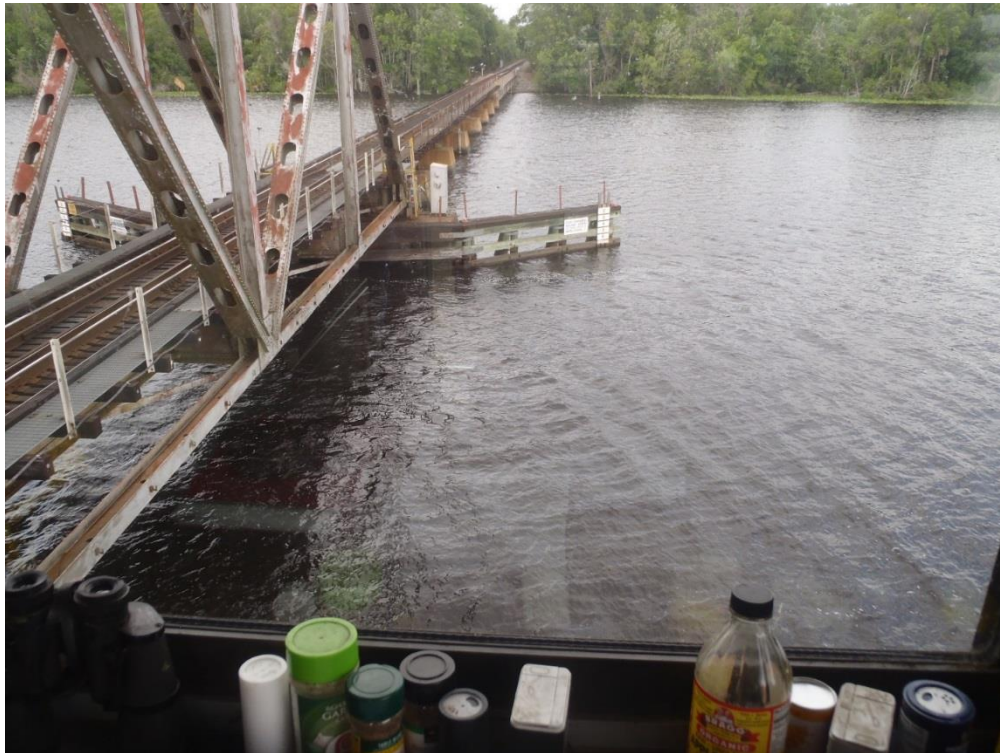
View from Buffalo Bluff Rail Road Bridge Office (daytime)
